ELEVATION CERTIFICATE

SECTION A – PROPERTY INFORMATION		FOR INSURANCE COMPANY USE
A1. Building Owner's Name Ernest E. Hudson		Policy Number:
A2. Building Street Address (including Apt., Unit, Suite, and/or Bldg. No.) or P.O. Route and Box No. 70 Lighthouse Way		Company NAIC Number:
City Woodbine	State Georgia	ZIP Code 31569

A3. Property Description (Lot and Block Numbers, Tax Parcel Number, Legal Description, etc.)
Lot 30 Misty Harbor Phase 1; Tax parcel 118H 030

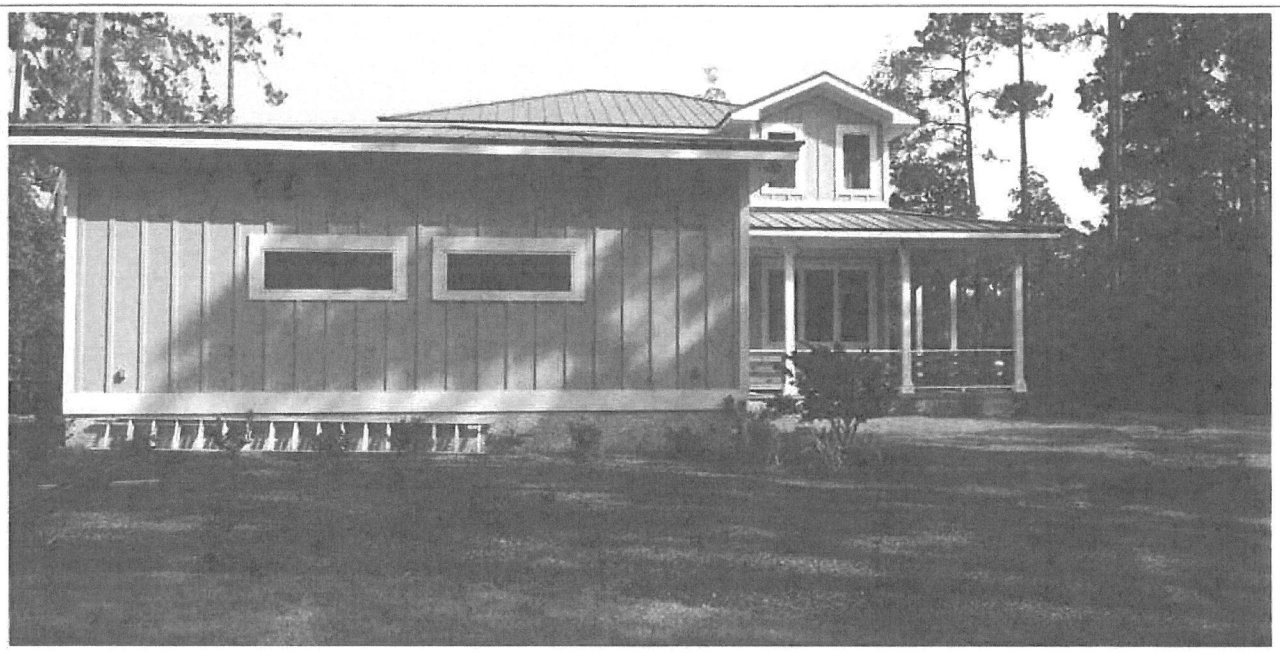
Photo One Caption Front View - Photo taken by AKM Surveying Inc. 07-18-2019

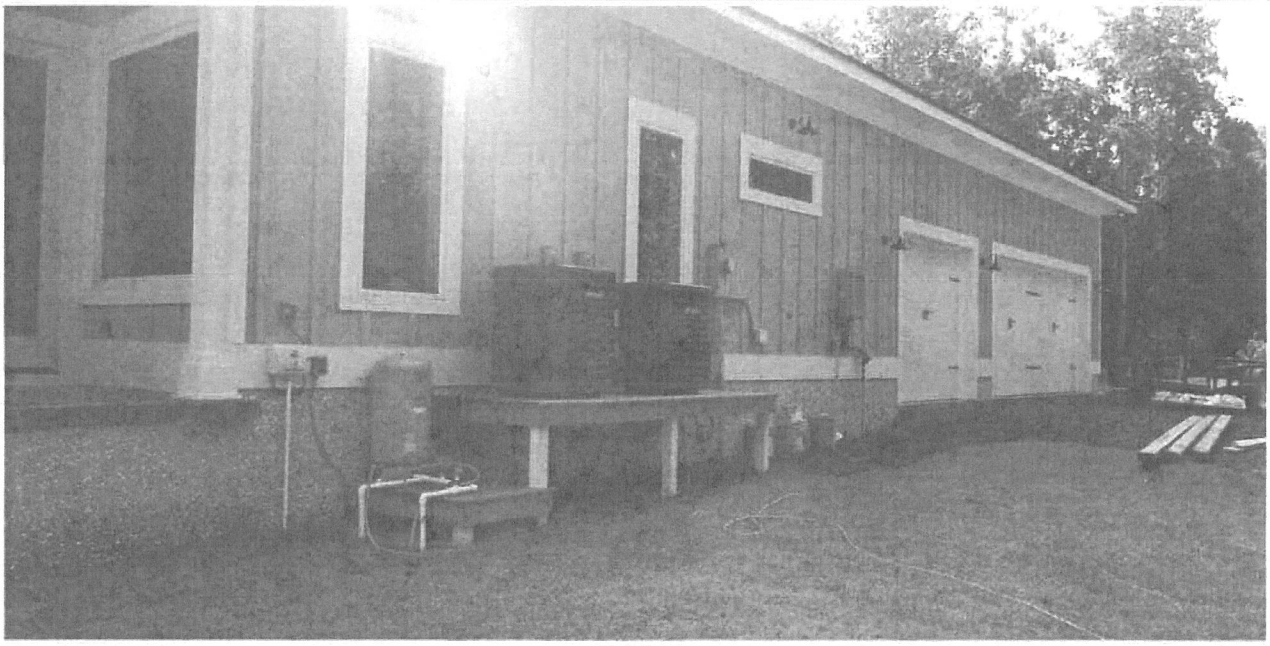
Photo Two Caption Left side View - Photo taken by AKM Surveying Inc. 07-18-2019

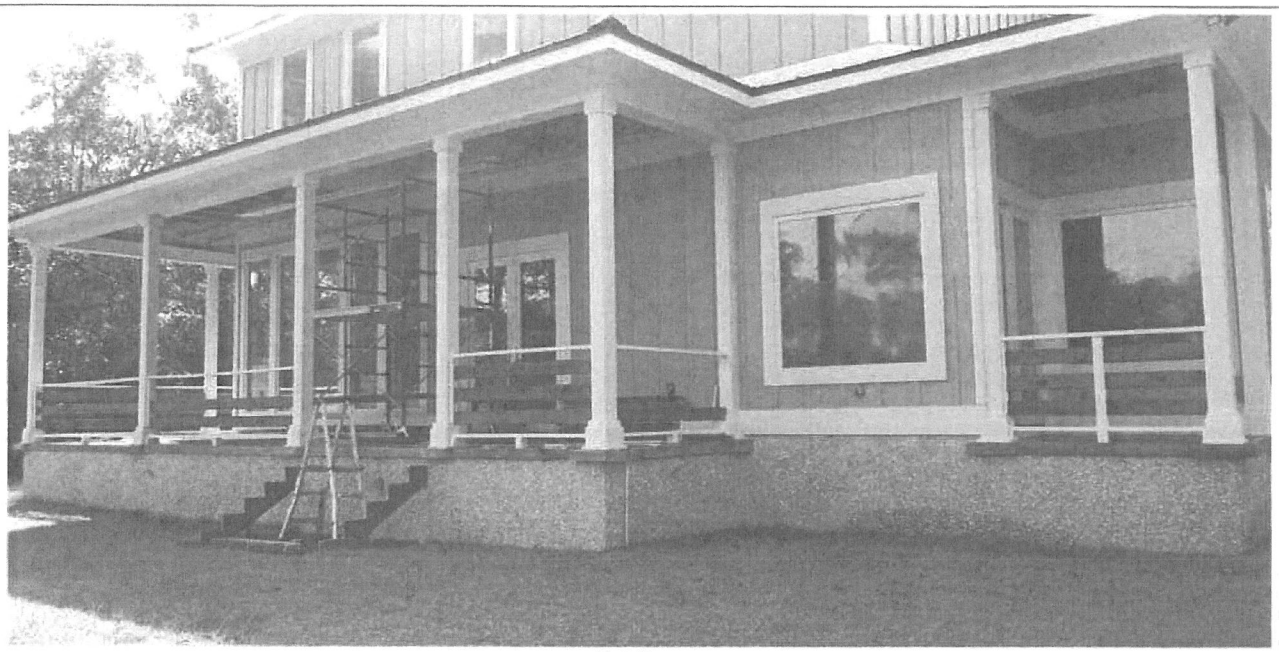
Photo Three Caption Rear View - Photo taken by AKM Surveying Inc. 07-18-2019

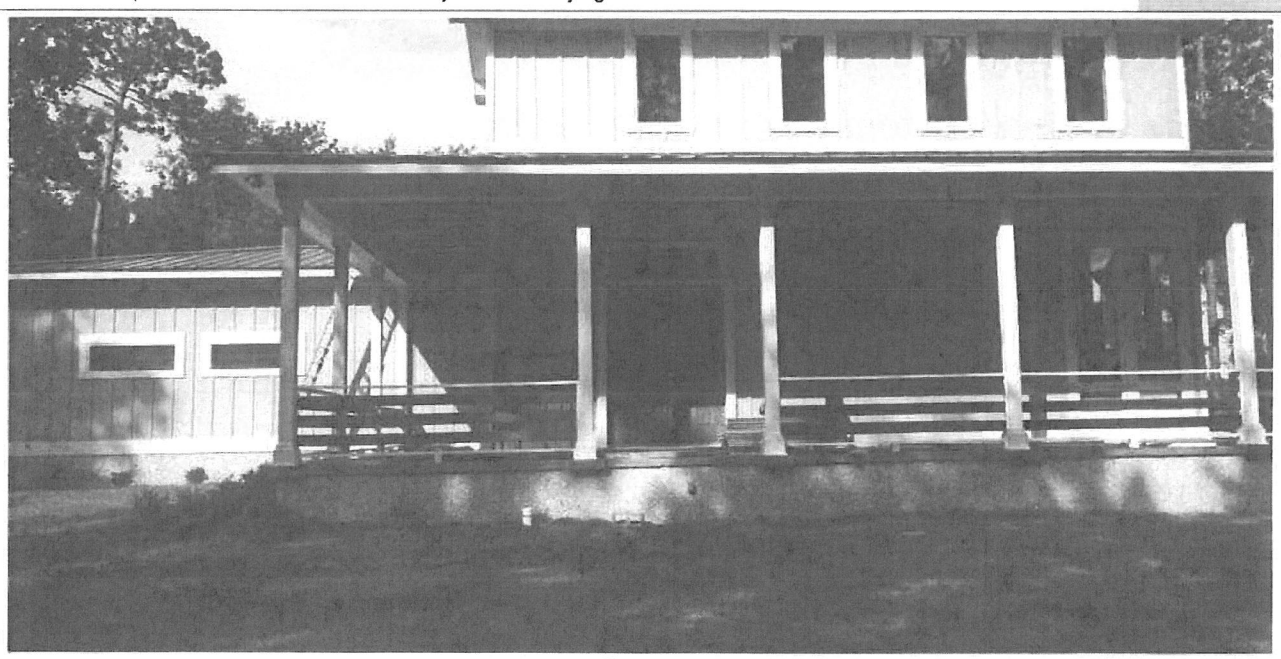
Photo Four Caption Right side View - Photo taken by AKM Surveying Inc. 07-18-2019
